## CASE STUDY

# Ferrography provides early warning of bearing failure, confirmed by vibration analysis.

The equipment being monitored is a General Electric Turbine Generator supported by journal bearings.

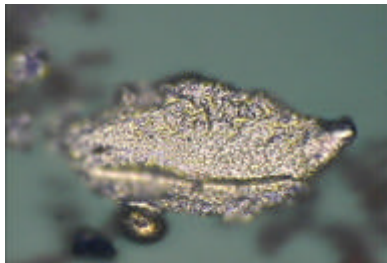
Figure 1

Upon examination of the ferrogram (wear particles deposited upon a glass slide for evaluation), babbitted material was identified (Figure 1). The babbitted particles were measured to 90 microns in size. The quantity of these particles observed was rated moderate to high. The size and quantity of particles present indicated a critical wear mode was

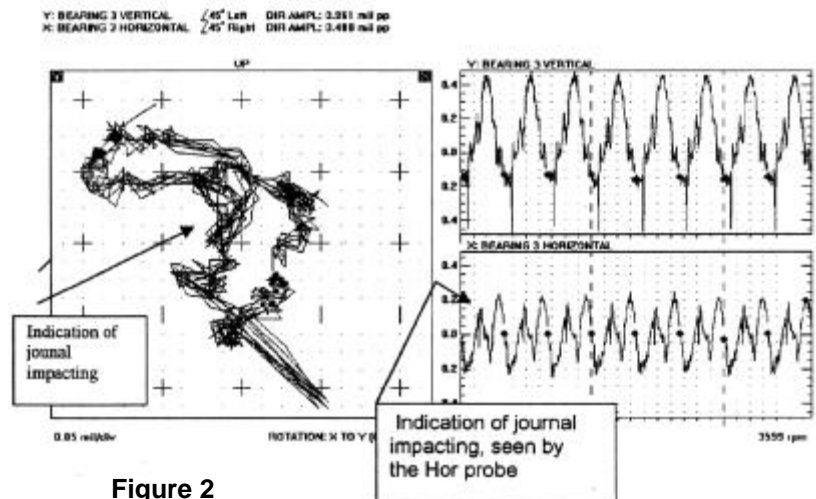
Figure 2

Journal #3 was identified through the vibration analysis as the bearing in the failure mode. The following vibration results were reported.

- Journal #3 is impacting a non-rotating element at the 7 o'clock position (Figure 2).
- The journal lift on the oil film shows only 2 mils lift. This indicates restricted or damaged bearings and/or seals.

- Journal lift plot shows the journal is moving to the left side of the bearing as observed from the turbine end. Journal movement should be to the right.
- Vibration response of journal #3 is very low as indicated by the bode plots performed.

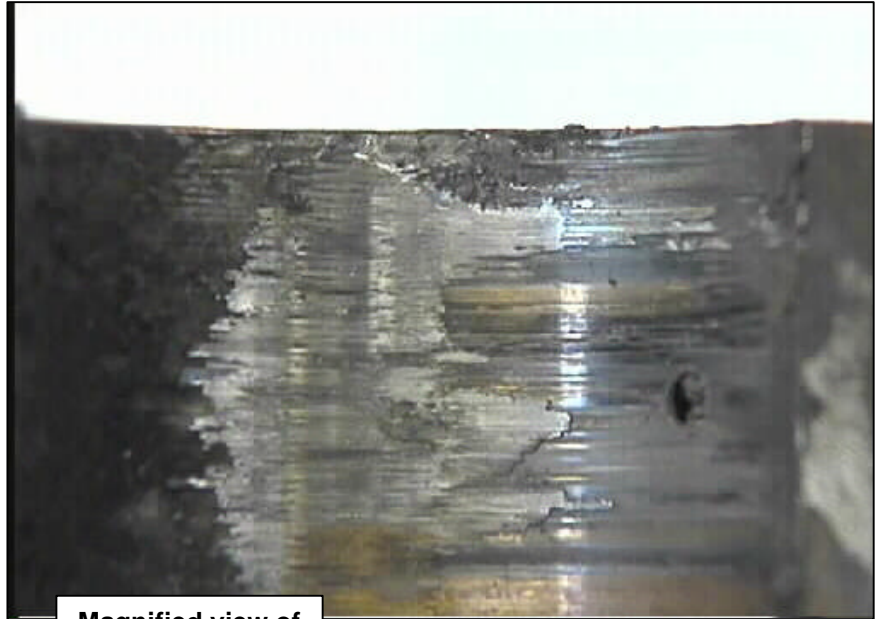
An inspection of this unit showed a wiped bearing. The timely identification of this failure mode saved our customer \$100,000.00.

**Magnified view of bearing surface**
